**Canon**

**The Best Image**

**Best Image Awards Compilation**

Ultrasound Category

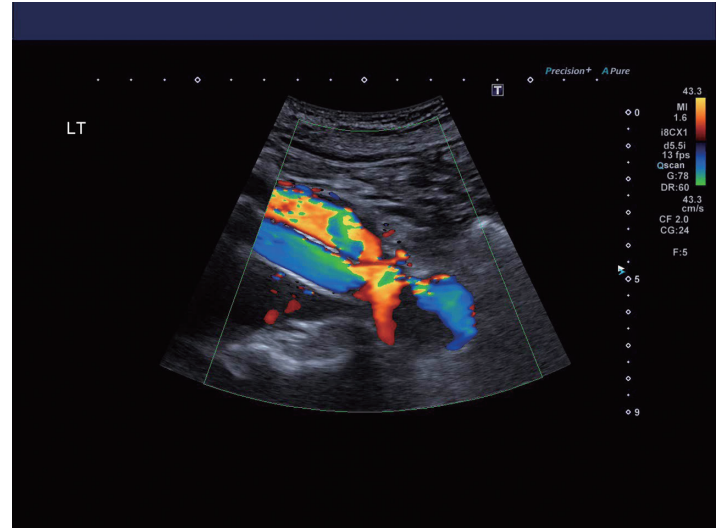
**Comments on images:** (a) Blood flow with a swirling pattern is seen inside the pseudoaneurysm. (b) High-velocity blood flow into the pseudoaneurysm is observed in the anastomosis between the left leg of the graft and the left common iliac artery. (c) The pseudoaneurysm and the inferior vena cava are adjacent to each other, and blood flow with a mosaic pattern is observed at their shared border. Blood flow from the pseudoaneurysm into the inferior vena cava can be confirmed. (d) Blood flow from the pseudoaneurysm into the inferior vena cava is seen in a fusion image generated by combining ultrasound and contrast CT images. Both the pseudoaneurysm and the fistula of the inferior vena cava are clearly depicted.

**Image findings:** A pseudoaneurysm with a maximum short diameter of about 75 mm was seen around the graft. High-velocity blood flow from the graft was observed in the anastomosis between the left leg of the graft and the

common iliac artery, with blood entering the area around the graft and forming a pseudoaneurysm. B-mode images showed low-intensity signals within the pseudoaneurysm, and color Doppler images showed blood flowing into the pseudoaneurysm. In addition, fusion images generated by combining ultrasound and CT images showed blood flowing from the pseudoaneurysm into the inferior vena cava, demonstrating that a fistula had formed between the pseudoaneurysm and the inferior vena cava.

**Technical comments:** After leakage from the anastomosis was identified, the color scale was adjusted to display the

direction and velocity of blood flow in a single image. In addition, the presence of a fistula was suspected because the pseudoaneurysm could easily be deformed and compressed by simply placing the transducer on the abdominal wall, suggesting that an escape route was available for reducing internal pressure. Fusion images were generated by combining ultrasound and CT images, making it possible to clearly visualize the positional relationships between the pseudoaneurysm and the inferior vena cava, to evaluate blood flow into the inferior vena cava in real time, and to provide clinically valuable images to the physicians caring for this patient.

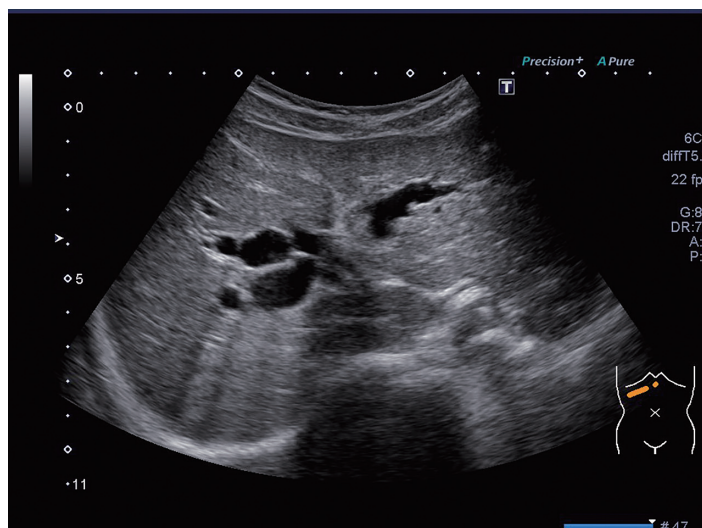
**Comments on images:** (a) The intrahepatic bile ducts are markedly dilated. (b) The common bile duct is dilated and joins the main pancreatic duct in the head of the pancreas. Multiple isointensity areas with the appearance of protein plugs are seen in the conjoined duct. (c) A dynamic image shows the conjoined common bile duct and main pancreatic duct.

**Image findings:** Enlargement of the pancreas was observed, with no obvious fluid retention noted in surrounding areas. The intrahepatic bile ducts were markedly dilated

out to the common bile duct, and the dilated common bile duct and the main pancreatic duct joined together in the head of the pancreas, forming a conjoined duct measuring approximately 14 mm in length. Multiple isointensity areas suspected to be protein plugs were observed in the lumen of the conjoined duct, with a large plug seen to be impacted immediately proximal to the papilla of Vater.

**Technical comments:** The finding of an anatomical abnormality in which the main pancreatic duct and the common bile duct join together outside the duodenal wall is indispensable for the definitive diagnosis of pancreaticobiliary maljunction, as illustrated by this case. Infants tend to have a thin abdominal wall with a small amount of subcutaneous fat, so a linear transducer with a frequency of 9 MHz\* (which is commonly used for carotid ultrasound examinations in adults) was used to examine the biliary system in this pediatric patient. This transducer provided valuable information for evaluating the conjoined bile duct and pancreatic duct.
